Johnson Residence - Asbestos Removal

Asbestos Removal Site Form

Date of Inspection
April 20, 2023

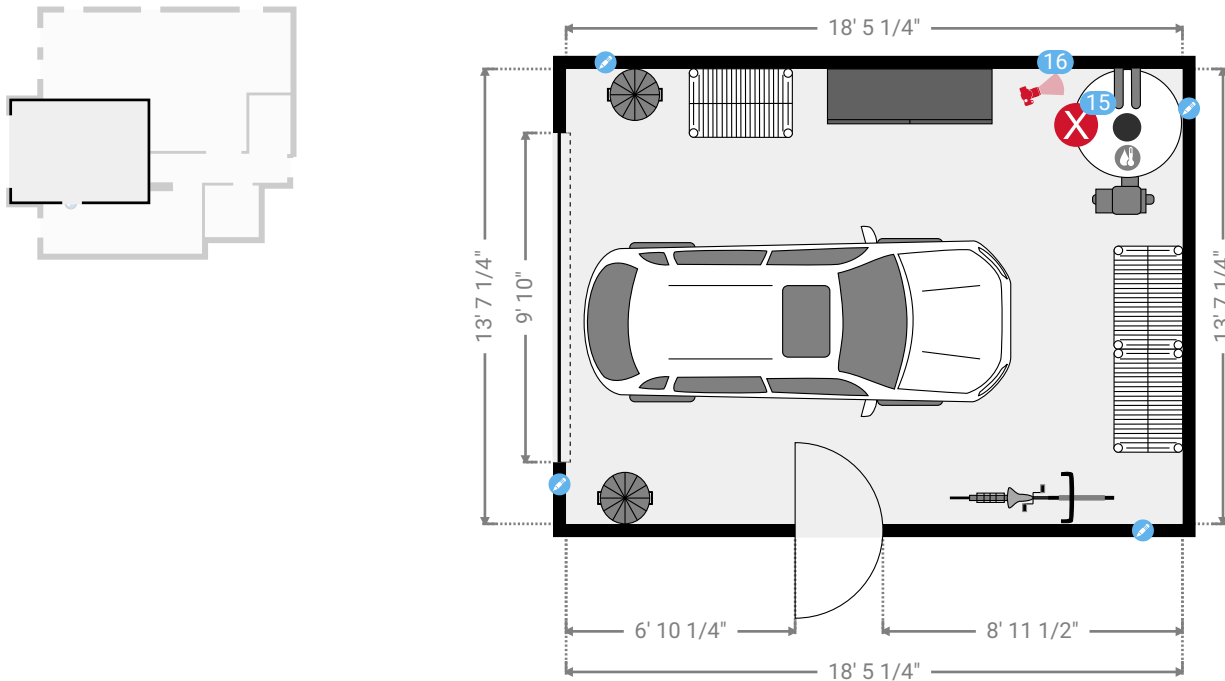
▼ Garage Ground Floor

15 TO REMOVE

To be removed due to asbestos insulation around pipes

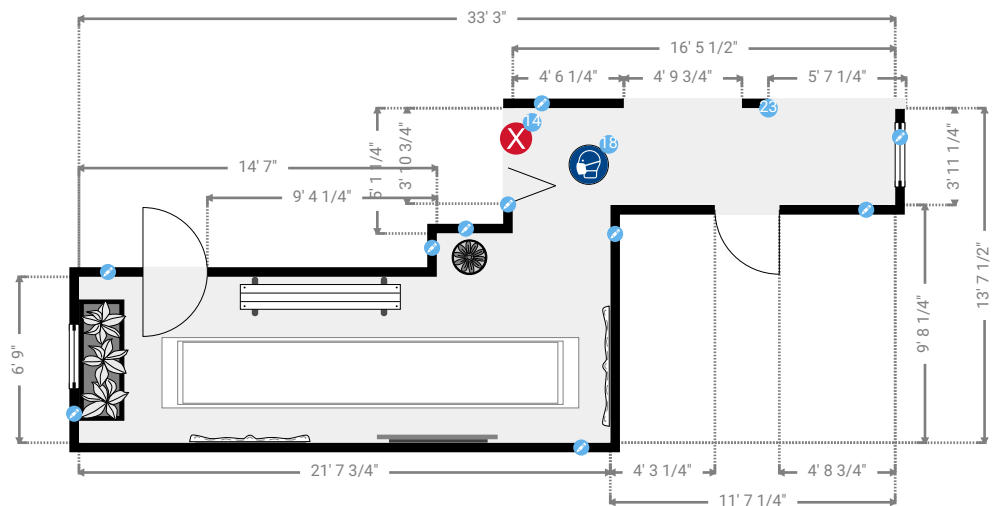
▼ Hallway Ground Floor

14 TO REMOVE

Oil furnace is using asbestos insulation - to be removed entirely

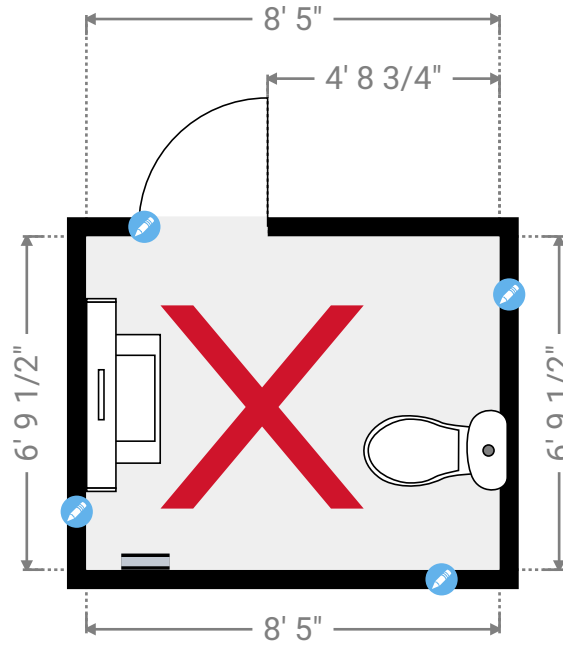
▼ Bathroom 1st Floor

Damaged vinyl flooring exposing asbestos materials

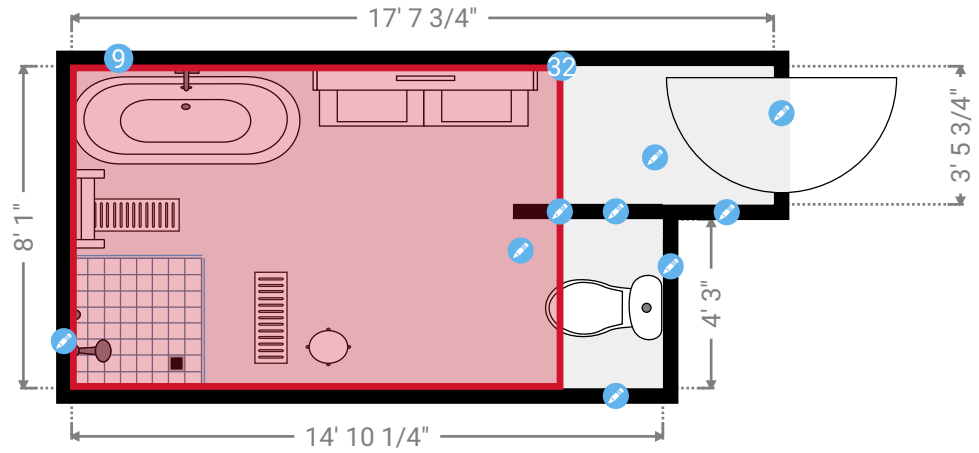
▼ Bathroom 2nd Floor

All hot water pipes in primary bath insulated with asbestos based materials

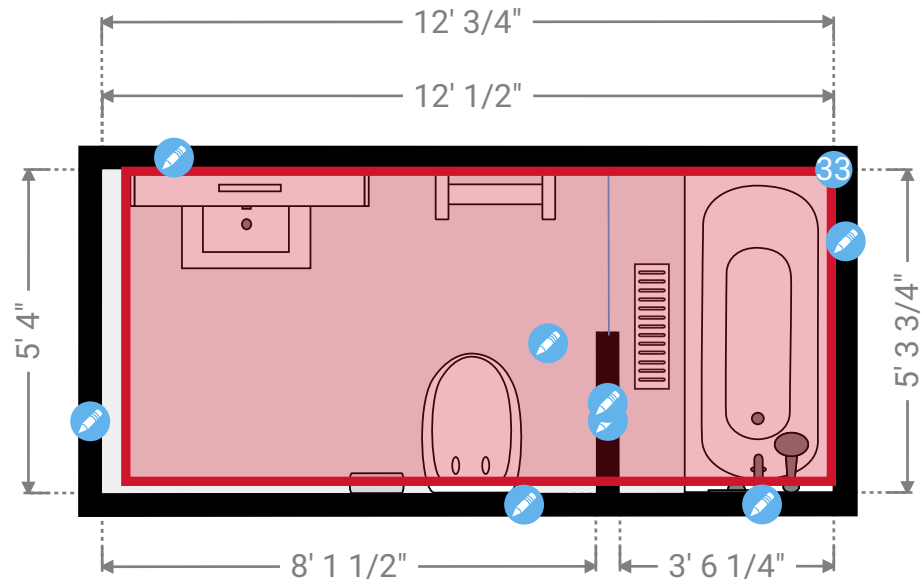
▼ Bathroom 2nd Floor

All hot water pipes in primary bath insulated with asbestos based materials

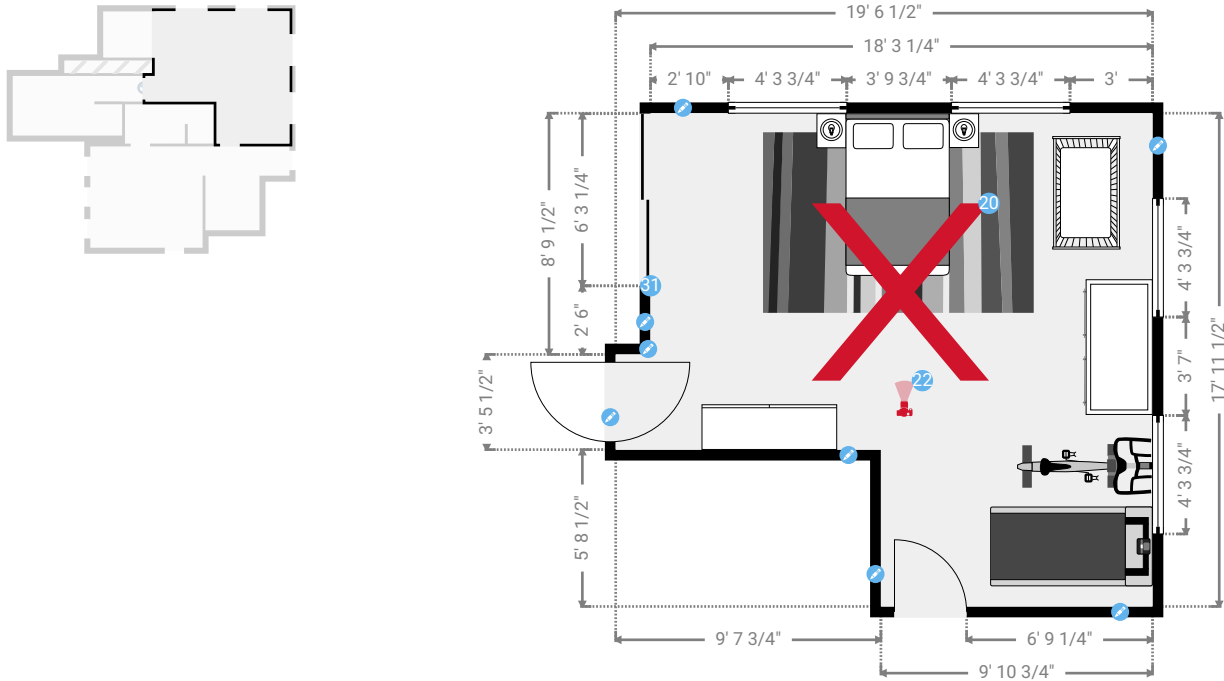
▼ Primary Bedroom 2nd Floor

Primary bedroom has asbestos based popcorn ceilings
